RAILROAD ACCIDENT REPORT

**DERAILMENT OF LOUISVILLE &
NASHVILLE RAILROAD COMPANY'S
TRAIN NO. 584 AND
SUBSEQUENT RUPTURE OF TANK CAR
CONTAINING LIQUEFIED PETROLEUM GAS
WAVERLY, TENNESSEE
FEBRUARY 22, 1978**

1. Report No. NTSB-RAR-79-1		2. Government Accession No.		3. Recipient's Catalog No.	
4. Title and Subtitle Railroad Accident Report -- Derailment of Louisville & Nashville Railroad Company's Train No. 584 and Subsequent Rupture of Tank Car Con- taining Liquefied Petroleum Gas, Waverly, Tennessee, February 22, 1978.				5. Report Date February 8, 1979

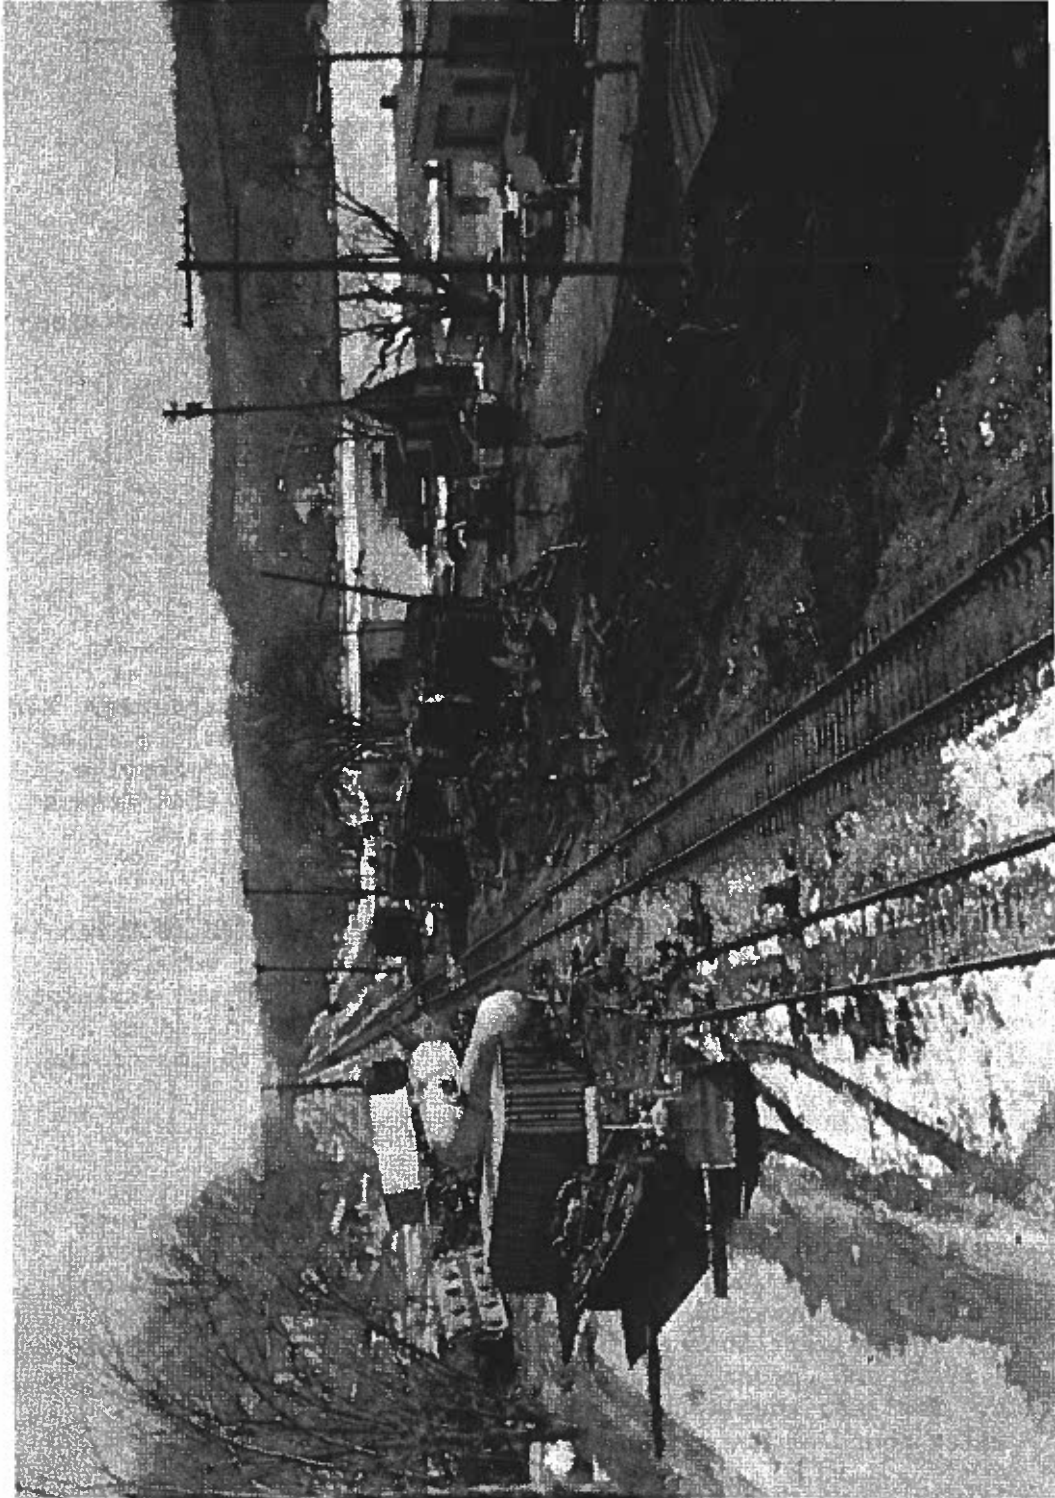
Figure 1. Location of tank cars immediately before rupture.

The L&N's wrecking crew continued to remove the derailed cars, and the main track was opened to rail traffic by 8:00 p.m., February 23. Tank trucks were ordered to unload the LPG from the relocated tank on the south end, since that car appeared to be the most severely damaged. An empty tank car was ordered so that the second tank could be unloaded on Friday morning, February 24. (See figure 1.)

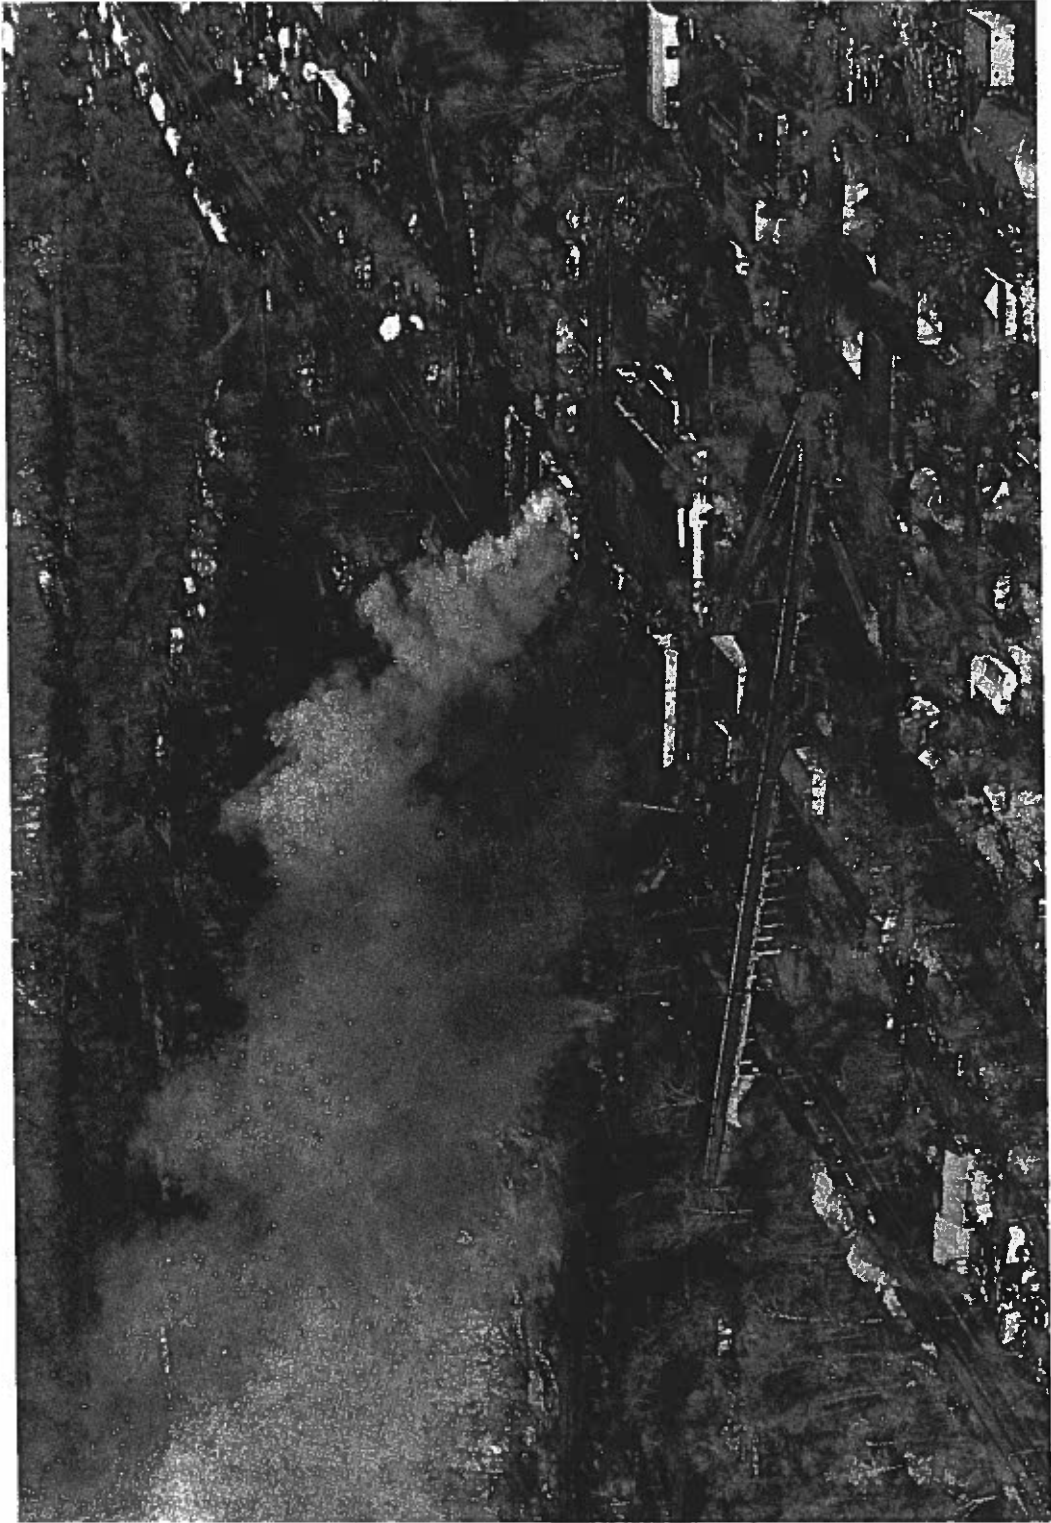
Figure 3. Accident site following the tank car rupture.

efforts were focused on preventing the second tank from exploding. By 3:45 p.m., deluge guns poured water onto the tank cars. By 5:00 p.m., all fires in the vicinity of the tank were extinguished and at 7:00 p.m., all significant fires in the area were under control. Sixty-four fire units with over 200 firemen were on site by 9:00 p.m. All personnel and 11 pieces of fire equipment remained on site until the second tank car of LPG was unloaded. (See figure 3.)
